Inspection Report

Minerals Regulatory Program

Mine Name: Cedar Springs	Permit Number: M/023/0059
Operator Name: Nephi Sandstone	Inspection Date: December 9, 2014
Inspector(s): Paul Baker and Wayne Western	Time: About 9:30-10:30 AM
Other Participants: Craig Dansie, Nephi Sandstone	Mine Status: Reclaimed

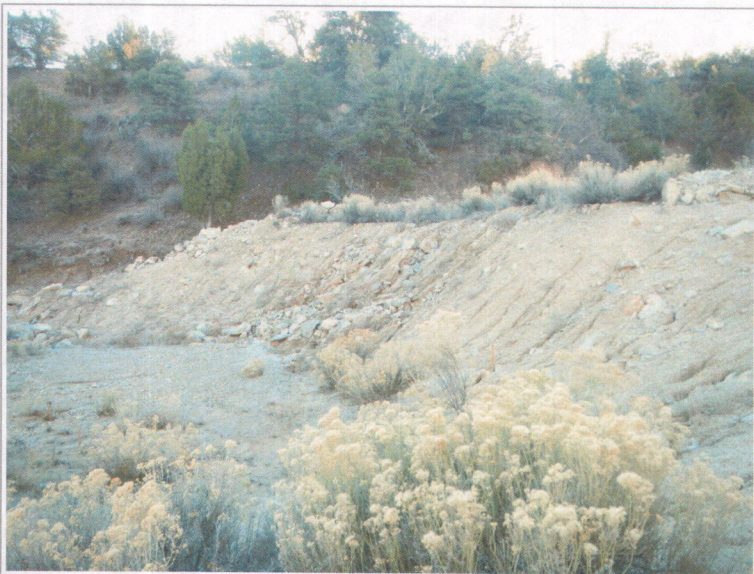
Photo 1

Previous inspections identified areas needing additional grading and seeding work. At the bottom of the site there is a pad where one can park. Just above this pad is a slope about 15 feet high and at a slope of about 1.5H:1V (Photo 1). This slope has essentially no vegetation and is eroding badly.

The lower slope—the one described above as being about 15 feet high—needs to be lessened and reseeded.

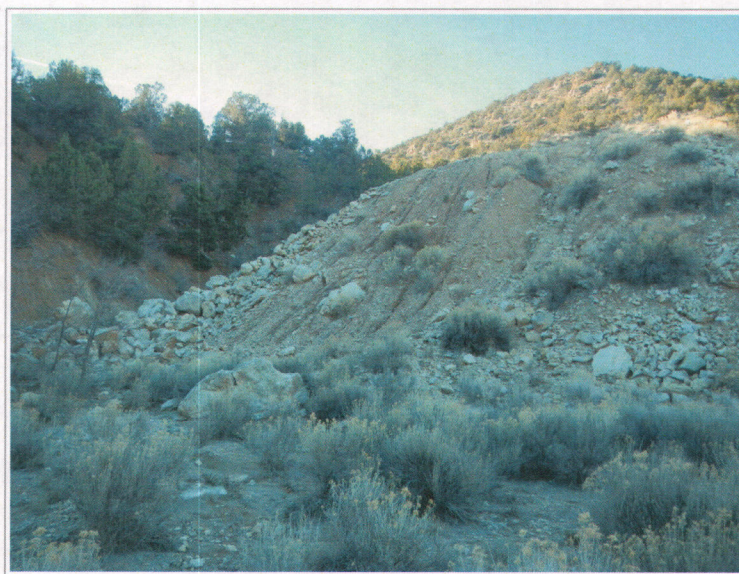
Photo 2

A little farther up the canyon is another slope about 30 feet high (Photo 2) and at a slope of about 1H:1V. Most of this slope is covered with less than a foot of loose material, but there is one portion where the loose material was eroded away revealing bedrock. This slope was previously identified as an area where the Division wanted the operator to do additional grading, but there was no way to know that the slope is basically a rock outcrop. The slope is moderately well vegetated.

There had clearly been a very heavy rainstorm in the area sometime within the past few months. There was evidence of this along the state highway, in the canyon below the mine, and at the mine site itself where there were gullies up to about two feet deep. The erosion on the 30-foot slope mentioned above was apparently caused by this storm. Most of the sediment generated from the erosion was deposited on the pads below the slopes though some almost certainly left the site.

Although the Division previously recommended that the upper slope be lessened, this is not possible without blasting, something that was not apparent when the Division first evaluated this slope. The slope meets regulatory angle requirements.

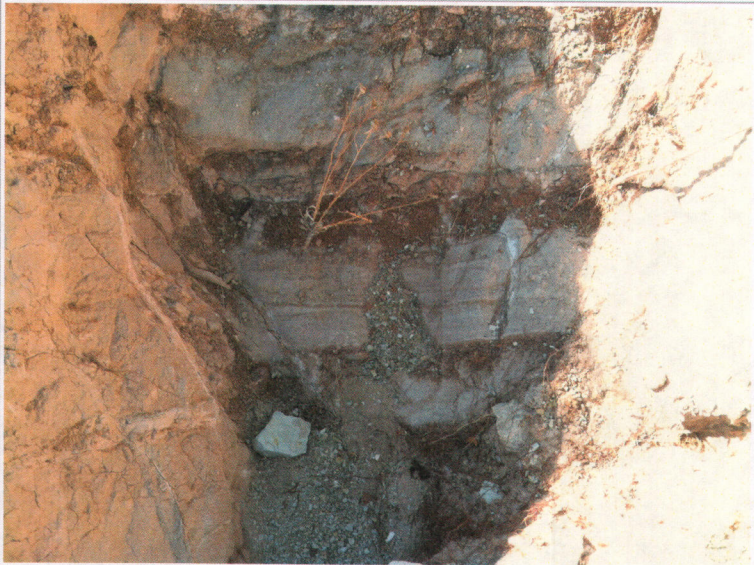
Photo 3

The majority of water coming down the canyon goes through a channel northeast of the pad, and this channel appears to be stable. Water that gathers on the site flows down the 30-foot slope and an old road to the side of this slope. In places this has eroded to bedrock (Photo 3).

We considered options for re-routing water to lessen erosion but could not see a good solution. The erosion we saw is likely unusual.
